## **Analysis of the causes of the crash of Flight MH17 (Malaysian Boeing 777)**

### **1. The Event**

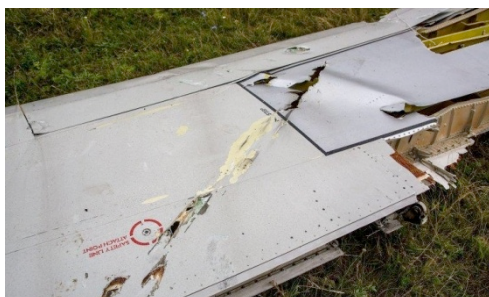
**Picture 1. Fragment of the Boeing 777 plane**  
**Фото 1. Фрагмент плоскости Boeing 777**

Of particular note are the holes folded inward in the fuselage. They are round-bored, and usually grouped. Such holes can only be formed by metal objects with a circular cross-section, possibly rods or shells from an aircraft gun. The question arises: who could deliver such projectiles to the aircraft, by what means, and what might they look like?

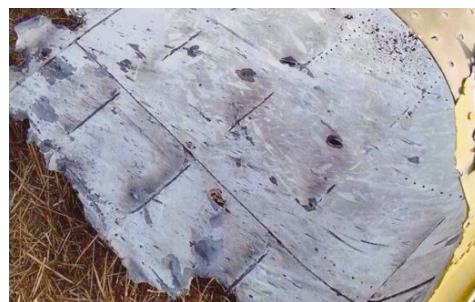
**Photo 2. Fragment of the Boeing 777's shell**  
**Фото 2. Фрагмент обшивки Boeing 777**

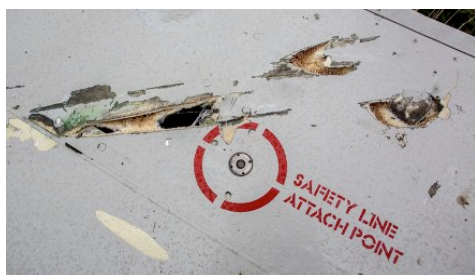
**Photo 3. Fragment of the Boeing 777 plane**  
**Фото 3. Фрагмент плоскости Boeing 777**

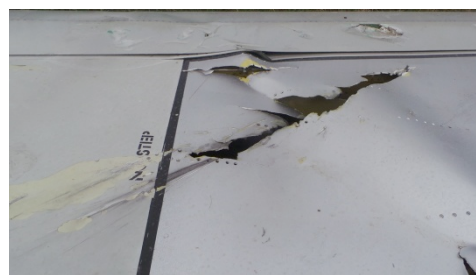
**Picture 4. Detail of the Boeing 777 plane**  
**Фото 4. Фрагмент плоскости Boeing 777**

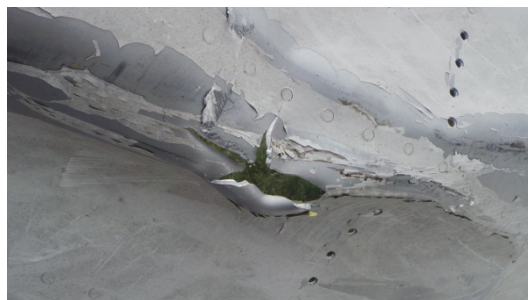
**Picture 5. Detail of the Boeing 777's fuselage**  
**Фото 5. Фрагмент фюзеляжа Boeing 777**

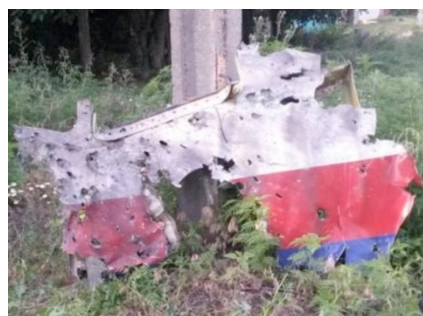
**Photo 6. Detail of the Boeing 777 cockpit**  
**Фото 6. Фрагмент кабины Boeing 777**

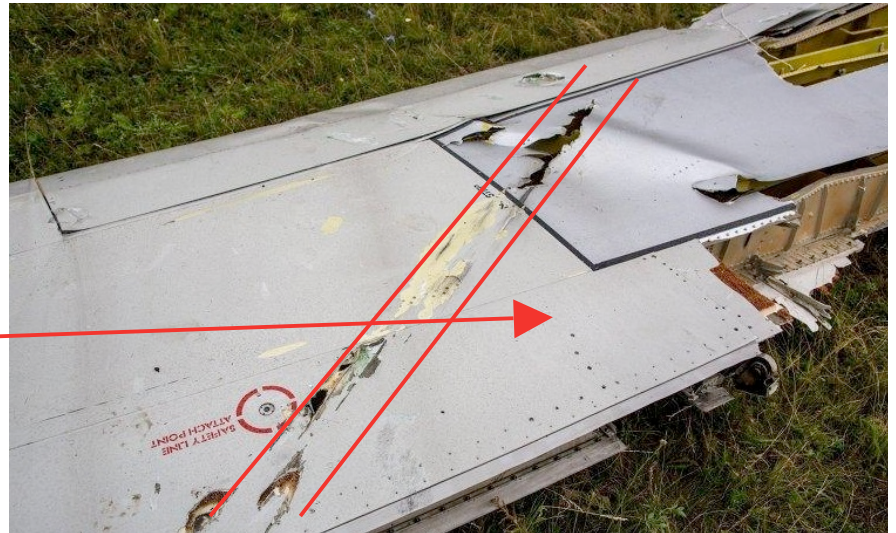
It would be logical to assume that the damage shown in photo 19 is more commonly associated with aircraft cannon shells of the GSH or SPPU type.

Damage to the Boeing 777 is not characteristic of the SAM "BUK-M1" missile

**Photo 19. Damage to the flat surfaces of the Boeing 777**  
**Фото 19. Повреждения плоскости Boeing 777**

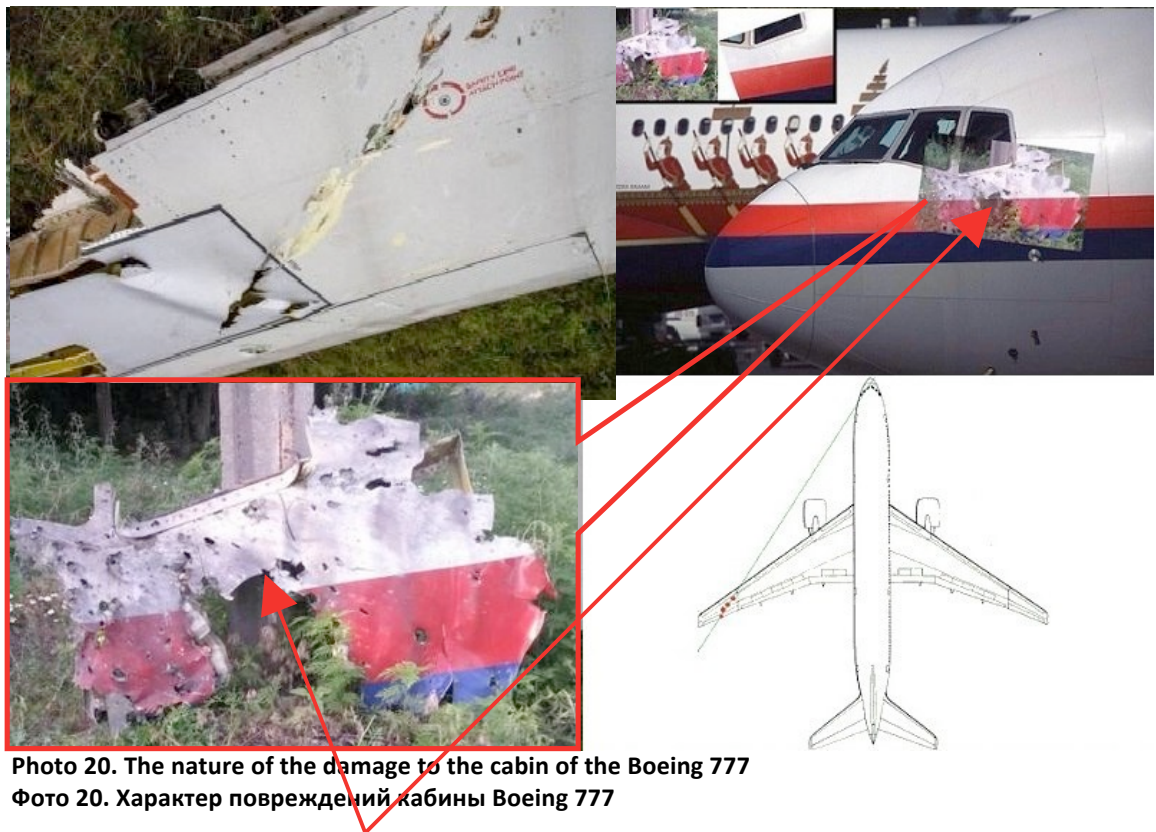
**Photo 20. The nature of the damage to the cabin of the Boeing 777**  
**Фото 20. Характер повреждений кабины Boeing 777**

The picture of the entry and exit holes in the cockpit of the Boeing 777 are fully consistent with the passage through the flight of shells from the 20-30 mm caliber guns found on military aircraft. This confirms the second version of what brought down the Boeing. This is further supported by the way the puncture holes are dispersed along the surface of the aircraft. The edges of the fragment of the fuselage from the left side of the cockpit are folded from the inside outward, which indicates that a significant blast occurred within the cockpit as a result of the dynamic impact of the shells on the right side. On the trim panel the characteristic entry holes are visible as well as some exit points. The edges of the holes are bent inward; they are much smaller and are circular in shape. The exit openings are less clearly formed; their edges are torn outward. In addition, it is clear that exit holes broke through double aluminum lining and tilted it outward. That is, the strike elements ([judging] by type of impact - aircraft cannon shells) punched right through the cockpit. The open rivets were also bent outward.

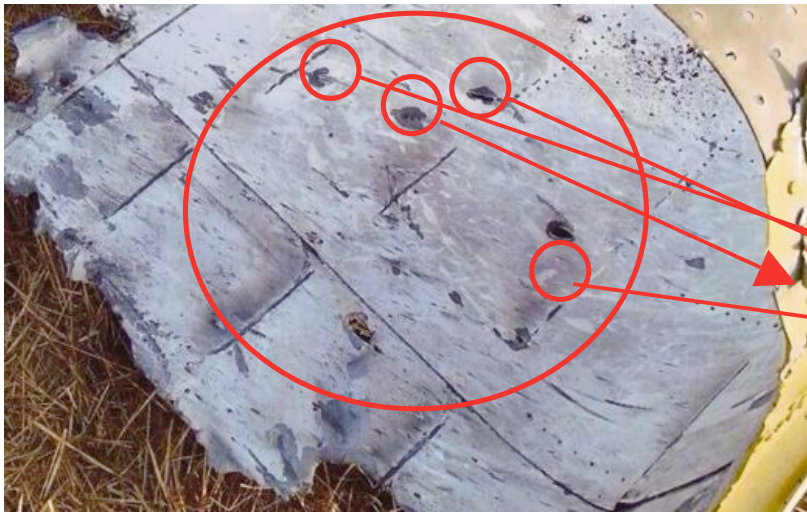
A fragment of the Boeing 777. Clearly seen are the entry holes in the outer layer, folded inward, caused by a 30-mm gun.

The inward folds are clearly seen, which are characteristic of this type of projectile.

**Photo 21. nature of the damage skin Boeing 777**  
**Фото 21. Характер повреждений обшивки Boeing 777**

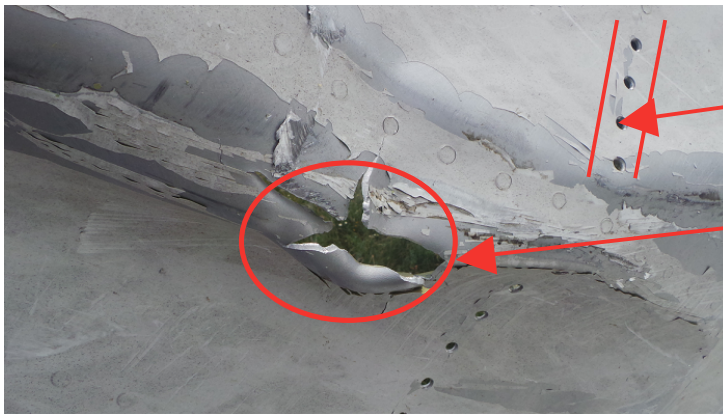
Fragment of Boeing 777.  
Taken off the rivet.

Rupture of the fuselage from the inside to the outside edges of the impact blow that is caused by any explosion inside the airplane, or a sharp drop in internal pressure at high altitude

**Photo 22. nature of the damage skin Boeing 777**  
**Фото 22. Характер повреждений обшивки Boeing 777**
