## **Analysis of the causes of the crash of Flight MH17 (Malaysian Boeing 777)**

### **1. The Event**

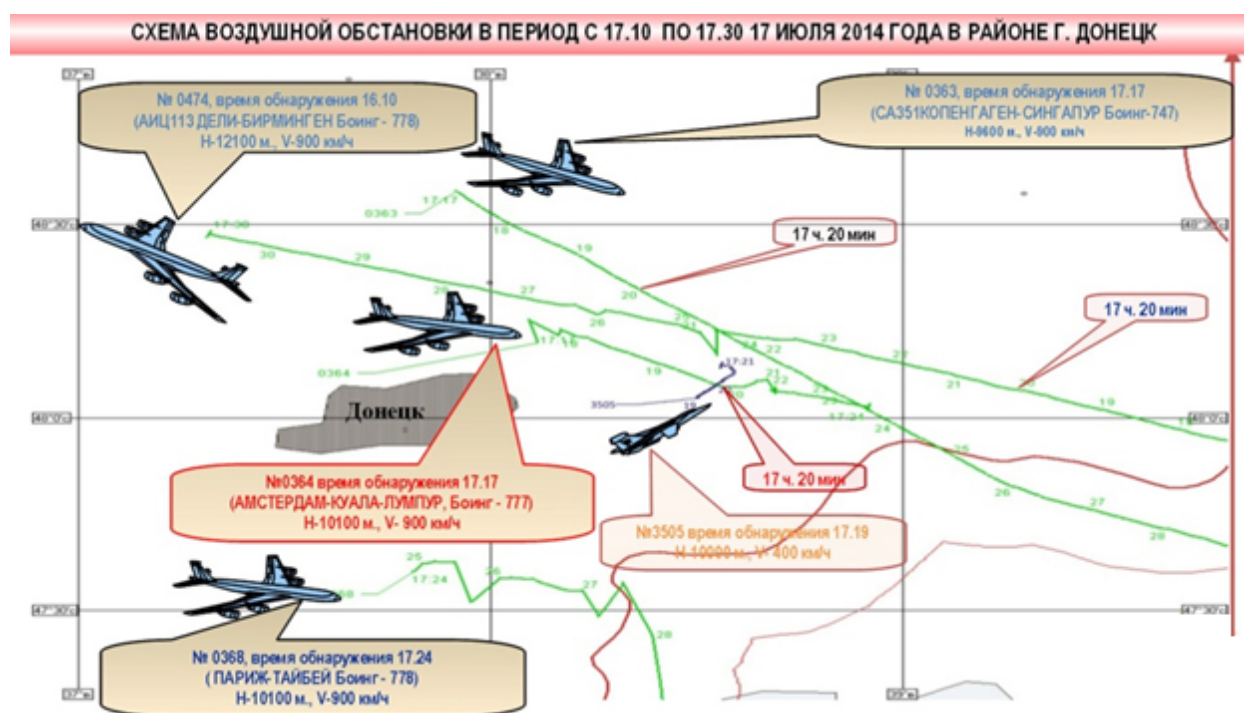
Fig.1 Diagram of the situation in the sky in the area where the Boeing 777 was destroyed (according to data from the Russian Federation Ministry of Defense)

In addition, Russian air traffic control recorded the ascent of a Ukrainian Air Force aircraft, presumably an Su-25, in the direction of the Malaysian Boeing 777. The distance between the SU-25 aircraft from the Boeing 777 was between 3 and 5 km.

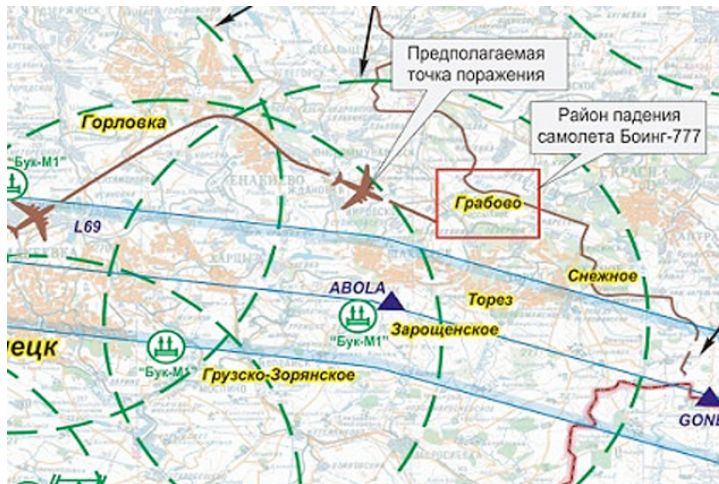
**Fig.2. Grouping Ukrainian SAM**  
**Рис.2. Группировка украинских ЗРК**

Grouping of Ukrainian troops on July 17 in the crash site numbered 3-4 Position "Buk-M1." This was stated by the Russian Ministry of Defense. The Chief of the Main Operations Directorate of the General Staff, Lieutenant-General Andrew Kartoplov, stressed that the Russian side has pictures from aerial locations of the individual units of the Ukrainian army in the south-east of Ukraine, in particular, "Bukov," 8 km from Lugansk. And on the morning of the day a Malaysian aircraft came down, Russian monitors found a battery SAM "Buk-M1" near the village of Zharoschenko. That day it was moved to Donetsk - in the area where the militia are located. We believe these data are objective and accurate.

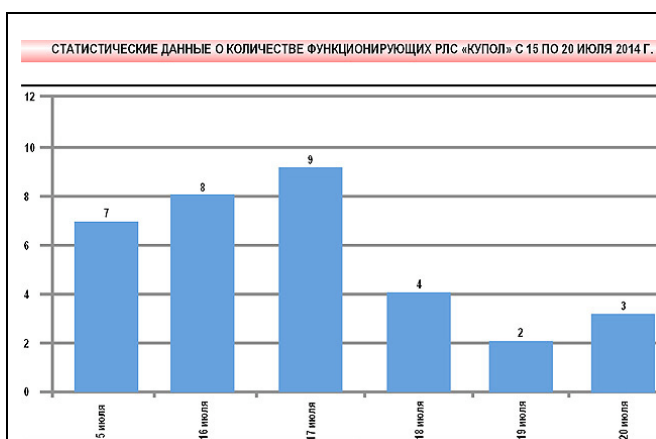
**Рис.3. Статистика активности украинских РЛС в районе гибели малайзийского Boeing 777**

7.1.2. The Russian Defense Ministry said that Russian military radar detected the "Dome" Ukrainian air defense system battery "Buk-M1", working, on the day of the Malaysian Boeing 777 disaster.

The activity of Radar Location Stations (RLS) can testify to the active deployment of military aviation insofar as the RLS is actively used for air reconnaissance and the transmission of information to the aviation control centre. It is common to provide data to assist the navigator in the coordination of single or groups of fighters to fulfil missions. Such missions include Air Superiority or ambush operations. In these missions an attack can take place either head on or in pursuit with co-ordination from the ground.
